# Lake Munson: Past, Present, and Future

Johnny Richardson,  
Water Quality Scientist

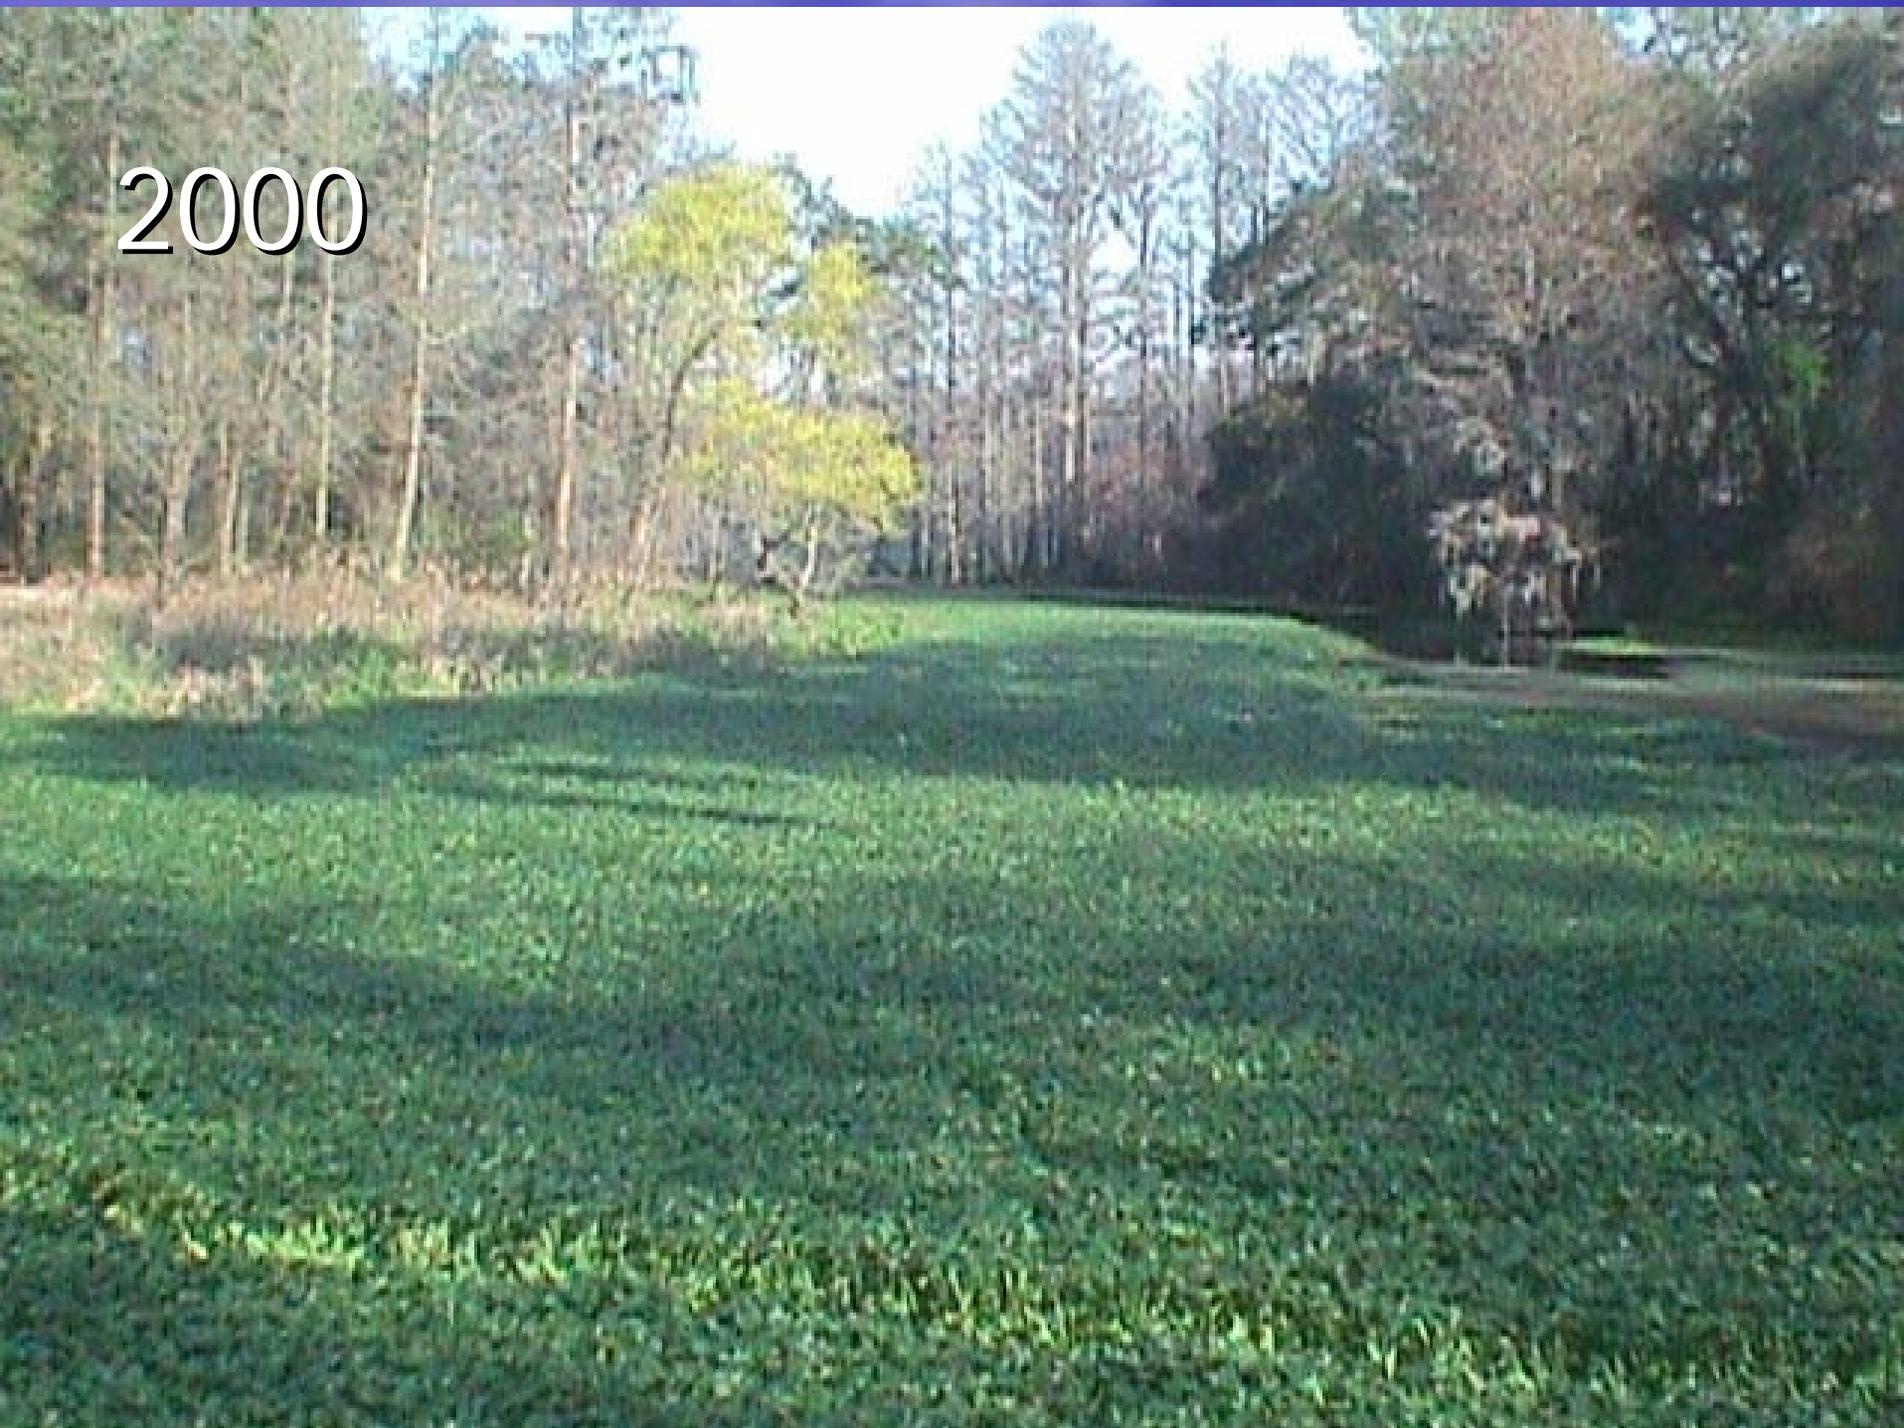
2000

- There has been a shift from a vascular plant community to an algal community

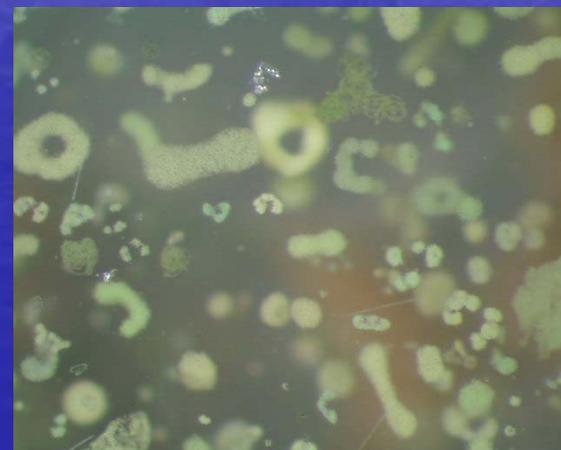
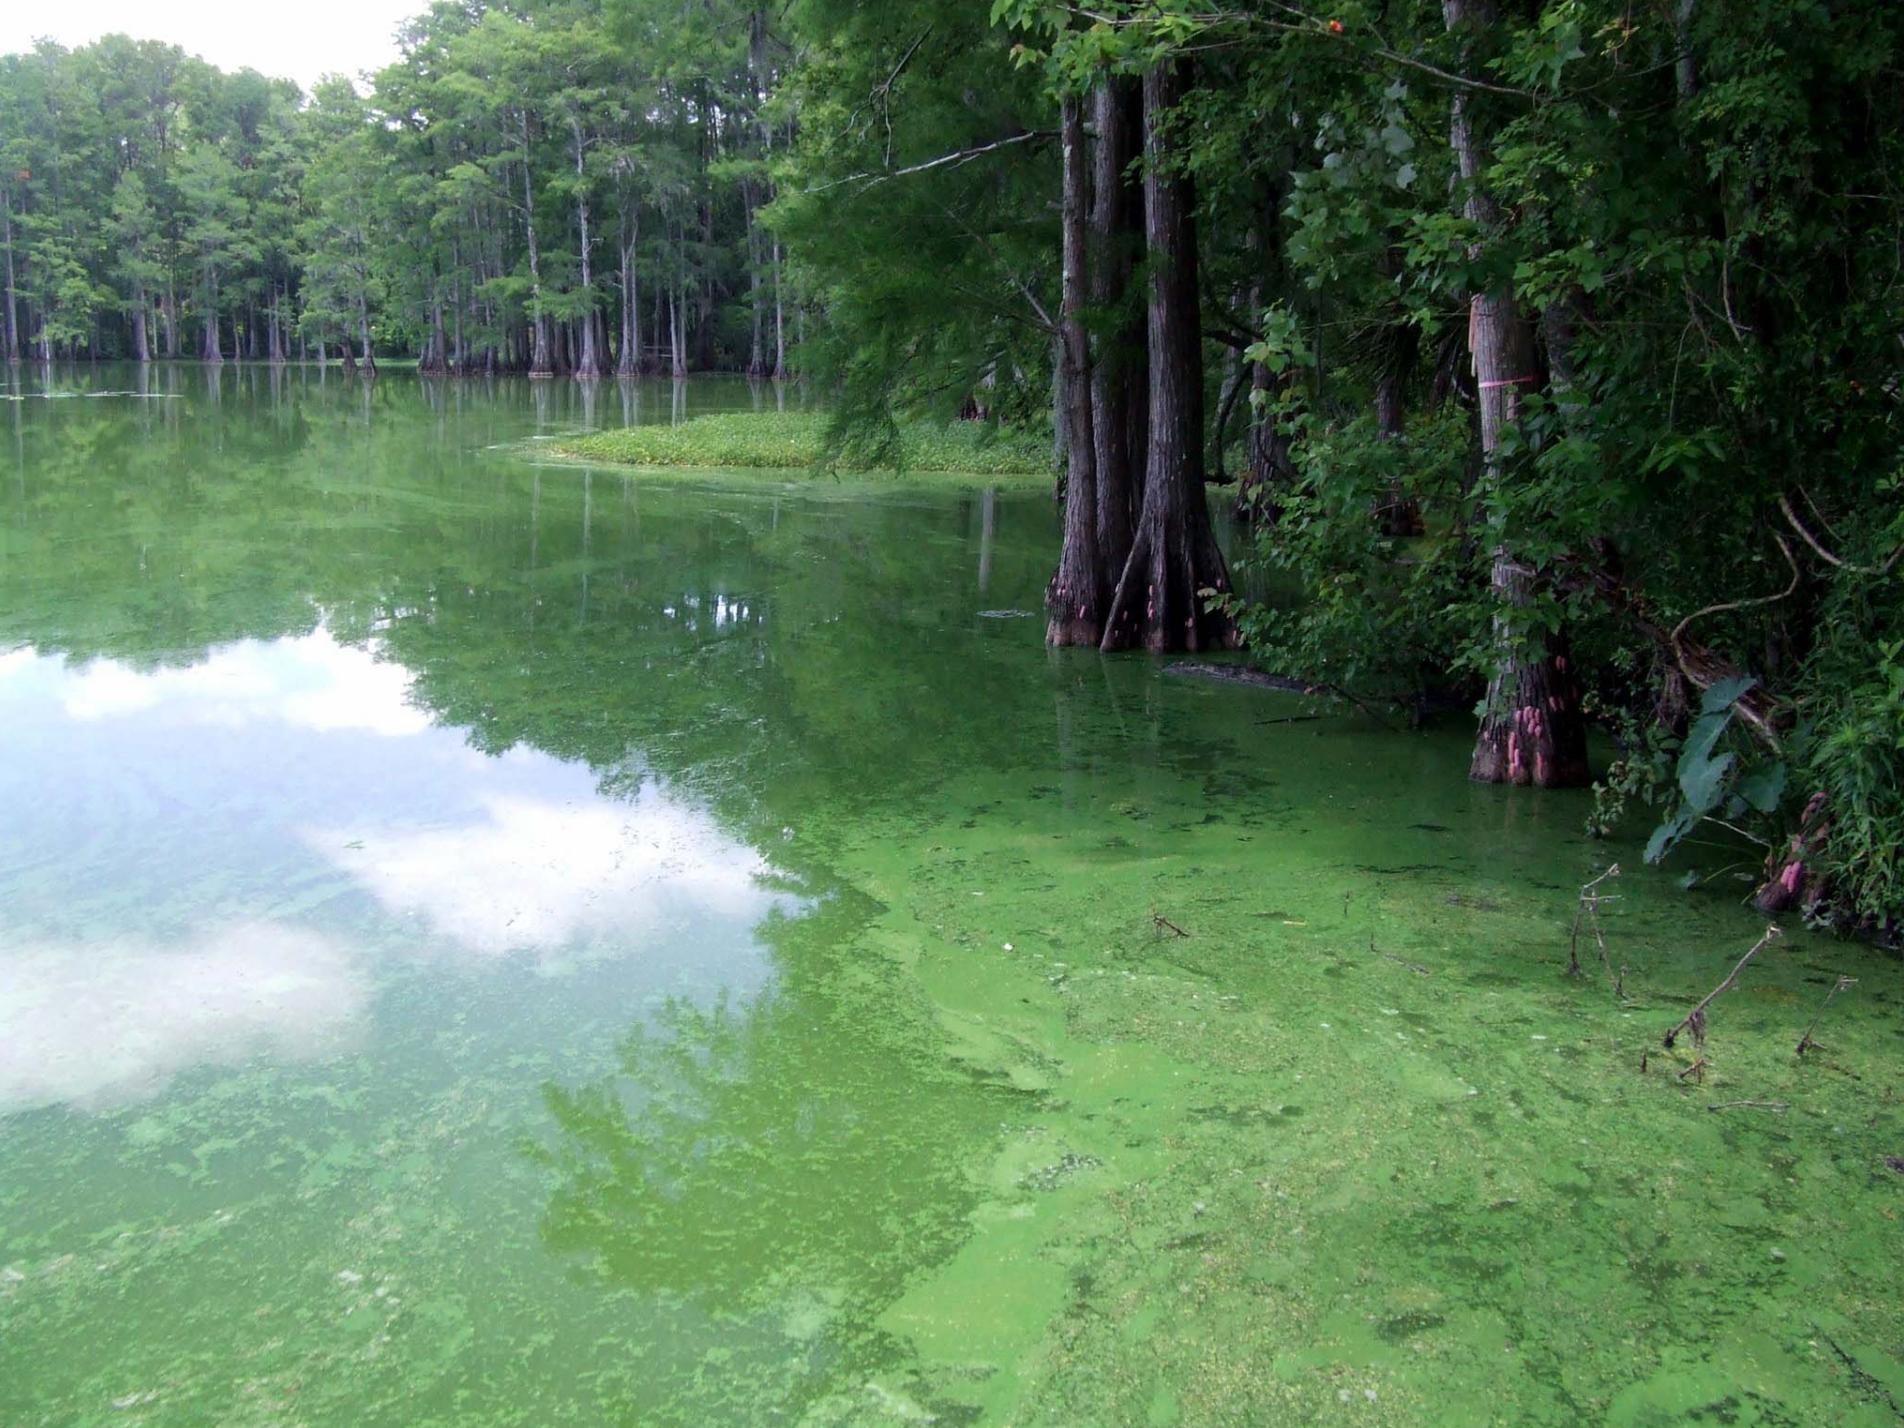
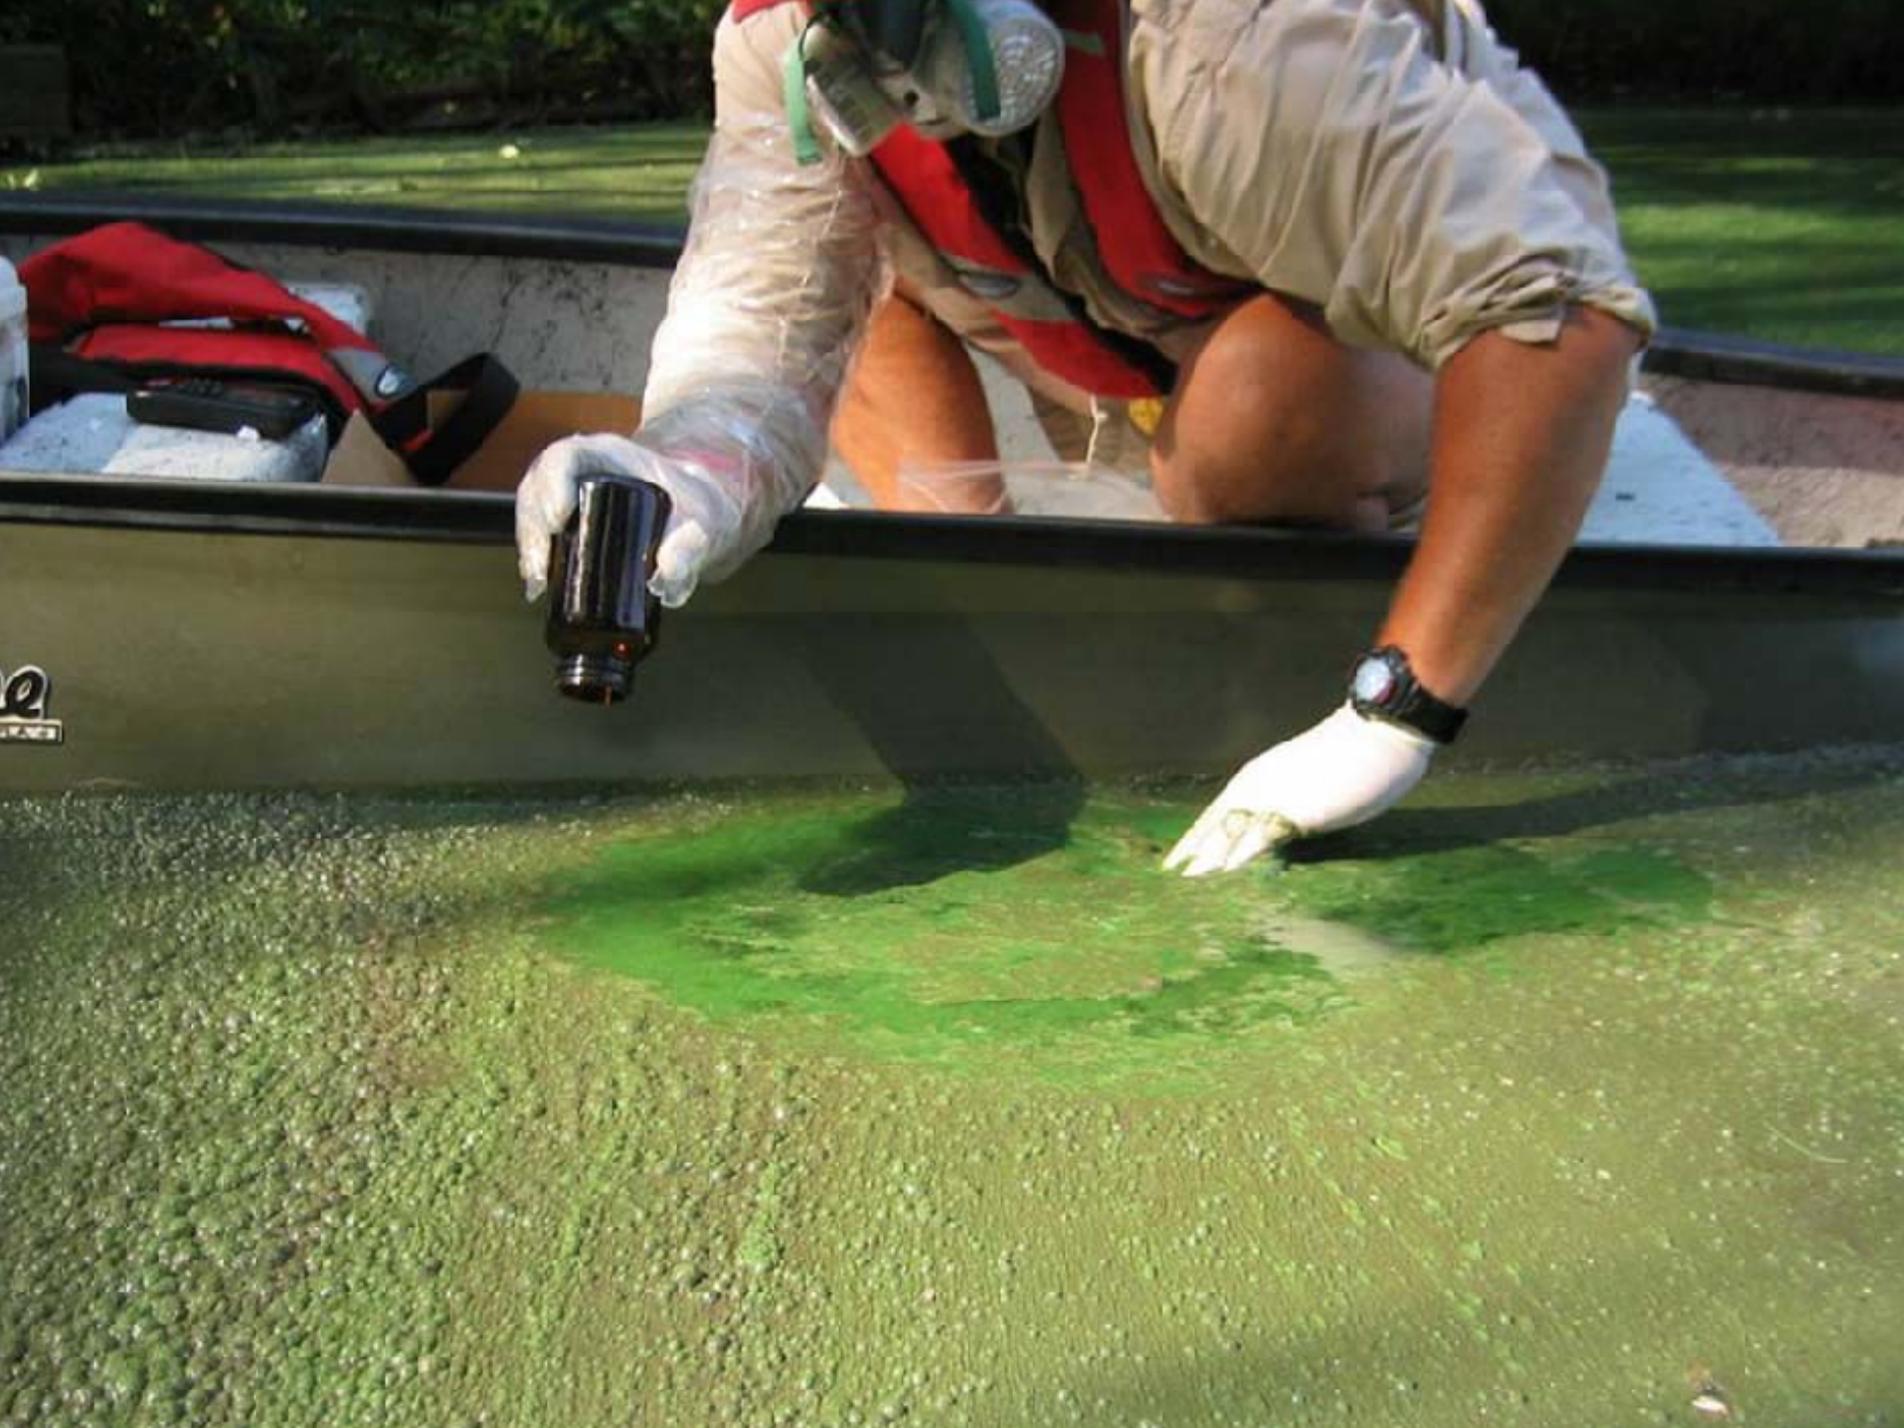
- During the Lake Munson blooms the dominant species was
  - *Microcystis aeruginosa*
    - blue-green algae (cyanobacteria) that grows naturally in many surface waters. In most bodies of fresh water and most weather conditions it does not pose a hazard to wildlife or human beings.
- But . . . .

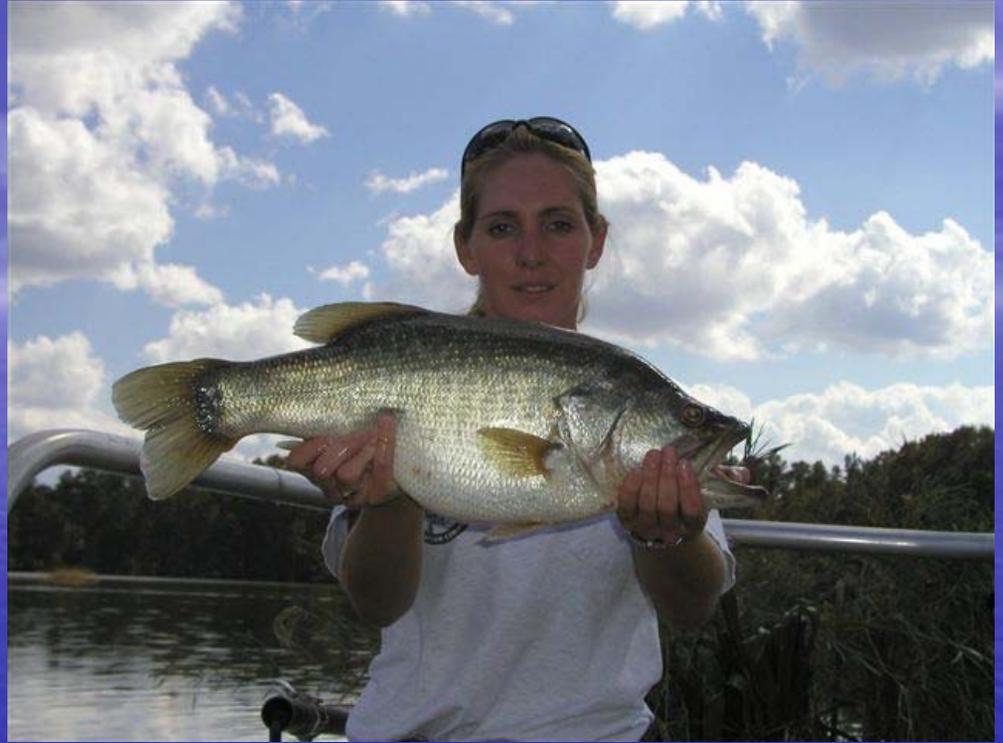
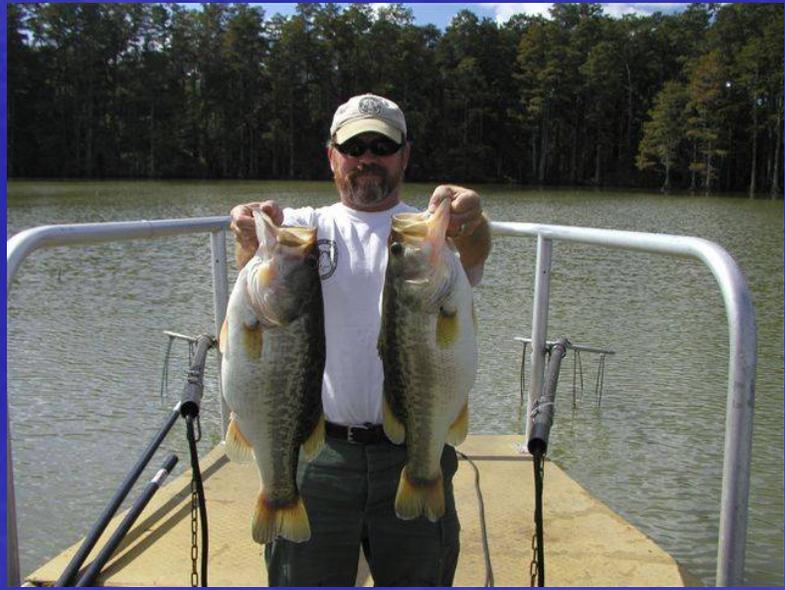
- These fish came out of Lake Munson

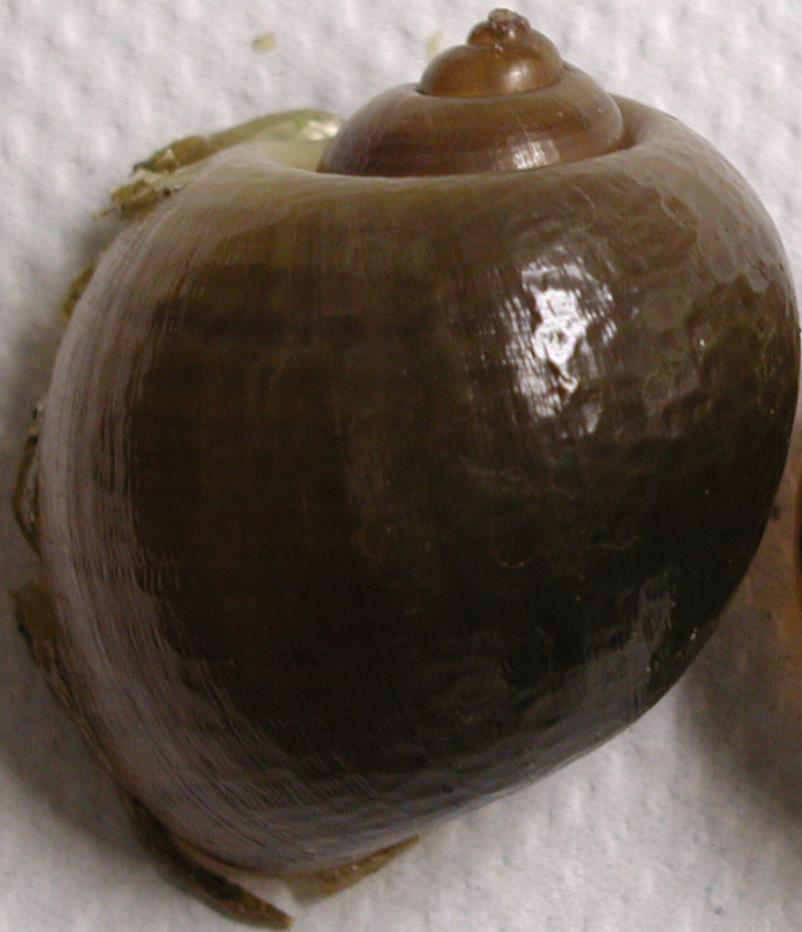
*P. canaliculata* complex

- channeled apple snails are bigger
- channeled apple snails have a groove (channel) between the whorls

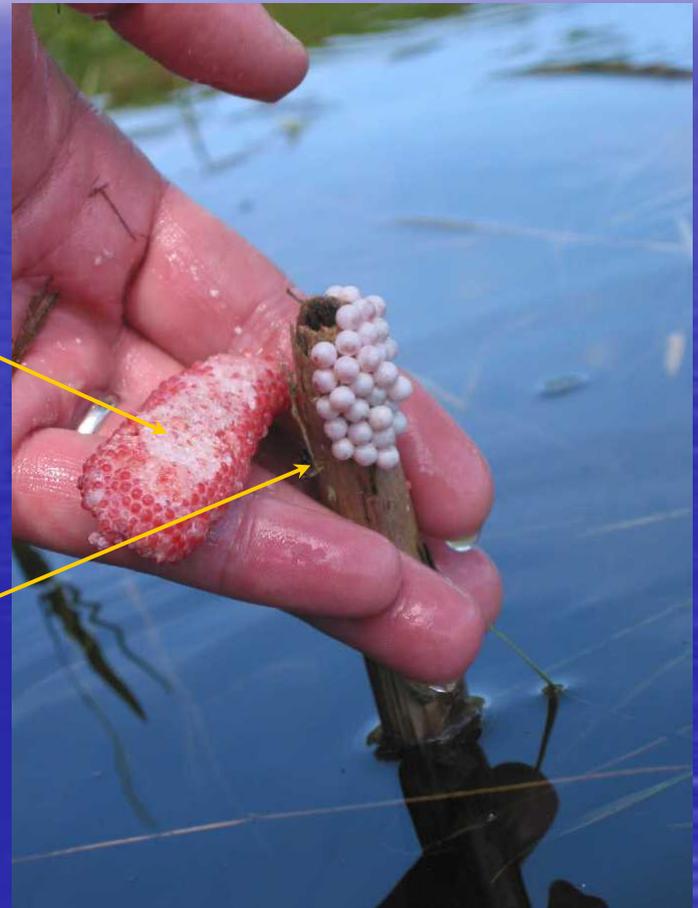
*Pomacea canaliculata* complex  
eggs ↓

- Channeled apple snail eggs very small, numerous, bright pink
- Native apple snail eggs larger, fewer, and white or light pink
